DEPARTMENT OF TRANSPORTATION**DIVISION OF ENGINEERING SERVICES**

Contract #: 04-0120F4Cty: SF/ALA Rte: 80 PM: 13.2/13.9File #: 69.28**WELDING INSPECTION REPORT****Resident Engineer:**Pursell, Gary**Address:** 333 Burma Road**City:** Oakland, CA 94607**Report No:** WIR-000042**Date Inspected:** 06-Nov-2006**Project Name:** SAS Superstructure**OSM Arrival Time:** 830**Prime Contractor:** American Bridge/Fluor Enterprises, a JV**OSM Departure Time:** 1730**Contractor:** Zhenhua Port Machinery Company, Ltd (ZPMC), Changxing Island **Location:** Shanghai, China**CWI Name:** Liu Liu**CWI Present:** Yes No**Inspected CWI report:** Yes No N/A**Rod Oven in Use:** Yes No N/A**Electrode to specification:** Yes No N/A**Weld Procedures Followed:** Yes No N/A**Qualified Welders:** Yes No N/A**Verified Joint Fit-up:** Yes No N/A**Approved Drawings:** Yes No N/A**Approved WPS:** Yes No N/A**Delayed / Cancelled:** Yes No N/A**Bridge No:** 34-0006**Component:** N/A**Summary of Items Observed:**

This Office of Structural Materials Quality Assurance Inspector observed welding and quality control functions during procedure qualification testing at the ZPMC facility in Shanghai, Republic of China toda

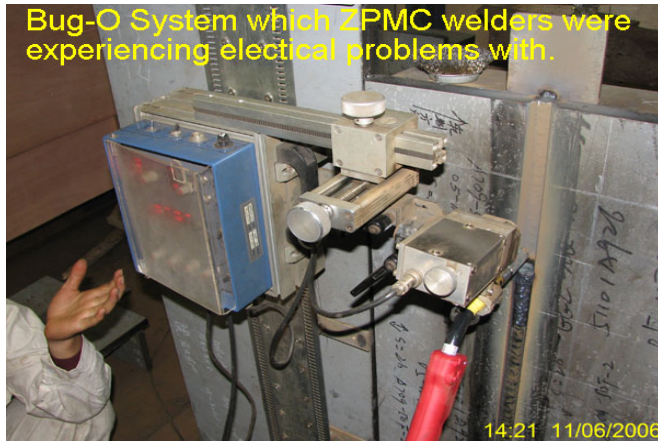
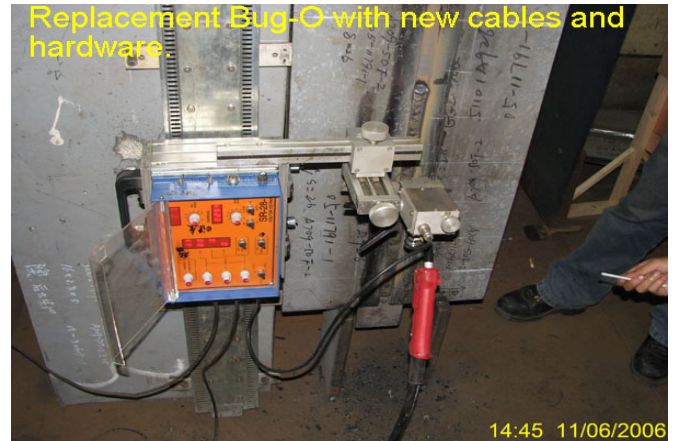
This Quality Assurance Inspector observed the Quality Control Inspector, Mr. Liu Liu witnessing the running of the flux-cored arc welding procedure qualification test HP2006105 in the shop at ZPMC. The test was being run to Paragraph 5.12 at for maximum heat input in the vertical welding position (3G). The welders were Lei Li Chao and Zhang Xing Jin who were using Hyundai, Supercored 71, and 1.4 millimeter diameter wire. Problems occurred once again during the running of the root and intermediate passes due to power fluctuation. After lunch, the welding of this procedure qualification plate was restarted after changing out the welding cable liner, contact tip and control cord. Problems were still encountered with the arc sputtering. Lei Li Chao tried welding without the use of the bug-o-system and a steady welding arc was then maintainable. Present for the welding was Craig A. Knops of Fluor who is the Senior Corporate Welding Engineer and Mr. Chen Bin, Quality Control Manager for ZPMC who were on hand to witness the problems being experienced by the welders. Problems continued so the bug-o-system currently in use was replaced by a similar unit. The welding came to an end when during the process of putting in the third pass the travel speed was 32% off from the average speed causing the welding to be out of tolerances.

A discussion was held with Liu Liu concerning the power fluctuations. Mr. Liu stated that they were going to suspend welding of the flux core welding to look into the cause of the electrical power problems.
